## CUSTOMER INFORMATION

### COMPLAINTS ON EVO ENGINE SERIES

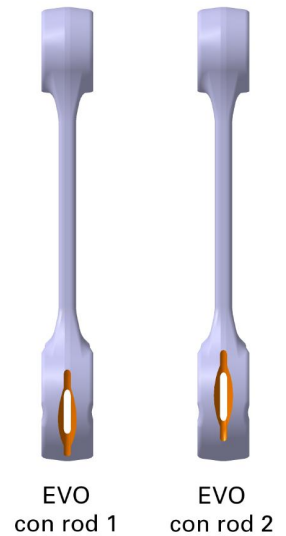
With the beginning of the racing season we have received complaints of failed evo 1 con rods.

These con rod failures have been analyzed and out of this the design of the evo 1 con rod has been slightly modified (= evo 2 con rod). This modification has significantly improved the durability of the con rod regarding the failures occurred on the market with evo 1 con rods.

As of following engine serial numbers the new evo 2 con rod is fitted as original equipment.

Customers owning a Rotax engine with an evo 1 con rod fitted will be offered, an evo 2 con rod kit free of charge if they would like to renew the con rod kit at the annual engine overhaul.

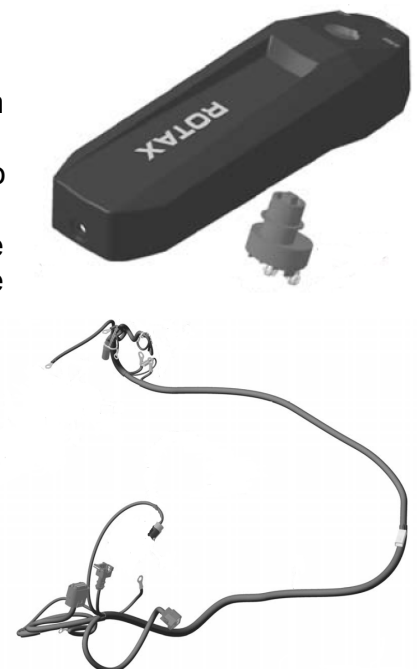
The claimed cable harnesses showed either broken connectors (ground wire, starter relay) or internal contact failures in connectors.

The vibration of the electrical components (ECU, ignition coil, magnet valve), caused by engine and vehicle vibrations, can have a negative impact on the durability of

the cable harness (depending on the installation of the cable harness in the kart). The cable harness has been modified in the critical areas to ensure durability and faultless function.

A failure of the cable harness is covered under the regular Rotax manufacturer's warranty. A failed cable harness will be replaced by a cable harness with improved design (as of January 2016).

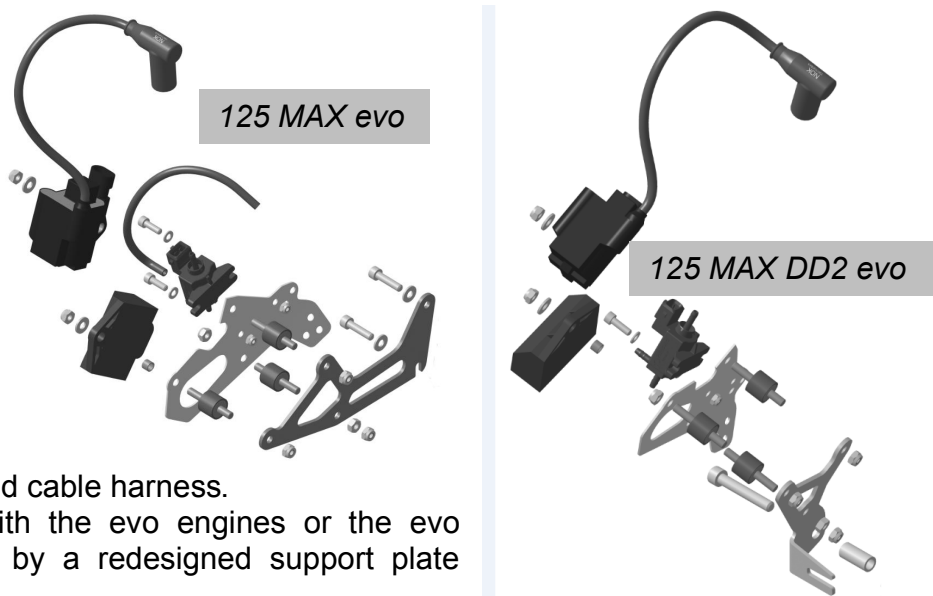
A lower vibration level of the electrical components (ECU, ignition coil, magnet valve) has a significant impact on the durability of the cable harness.

To minimize the vibration level of the electrical components BRP-Rotax will initiate an exchange campaign for the support plate which carries the ECU, ignition coil and magnet valve in combination with the improved cable harness.

The support plate supplied with the evo engines or the evo upgrade kits will be replaced by a redesigned support plate system (see illustrations).
